## Memorial

**Classification:** Community Park – est. 1948  
**Size:** 11.5 Acres  
**Location:** 5181 Memorial Trail SE

**Memorial Park**  
Park System Master Plan  
Prior Lake, MN

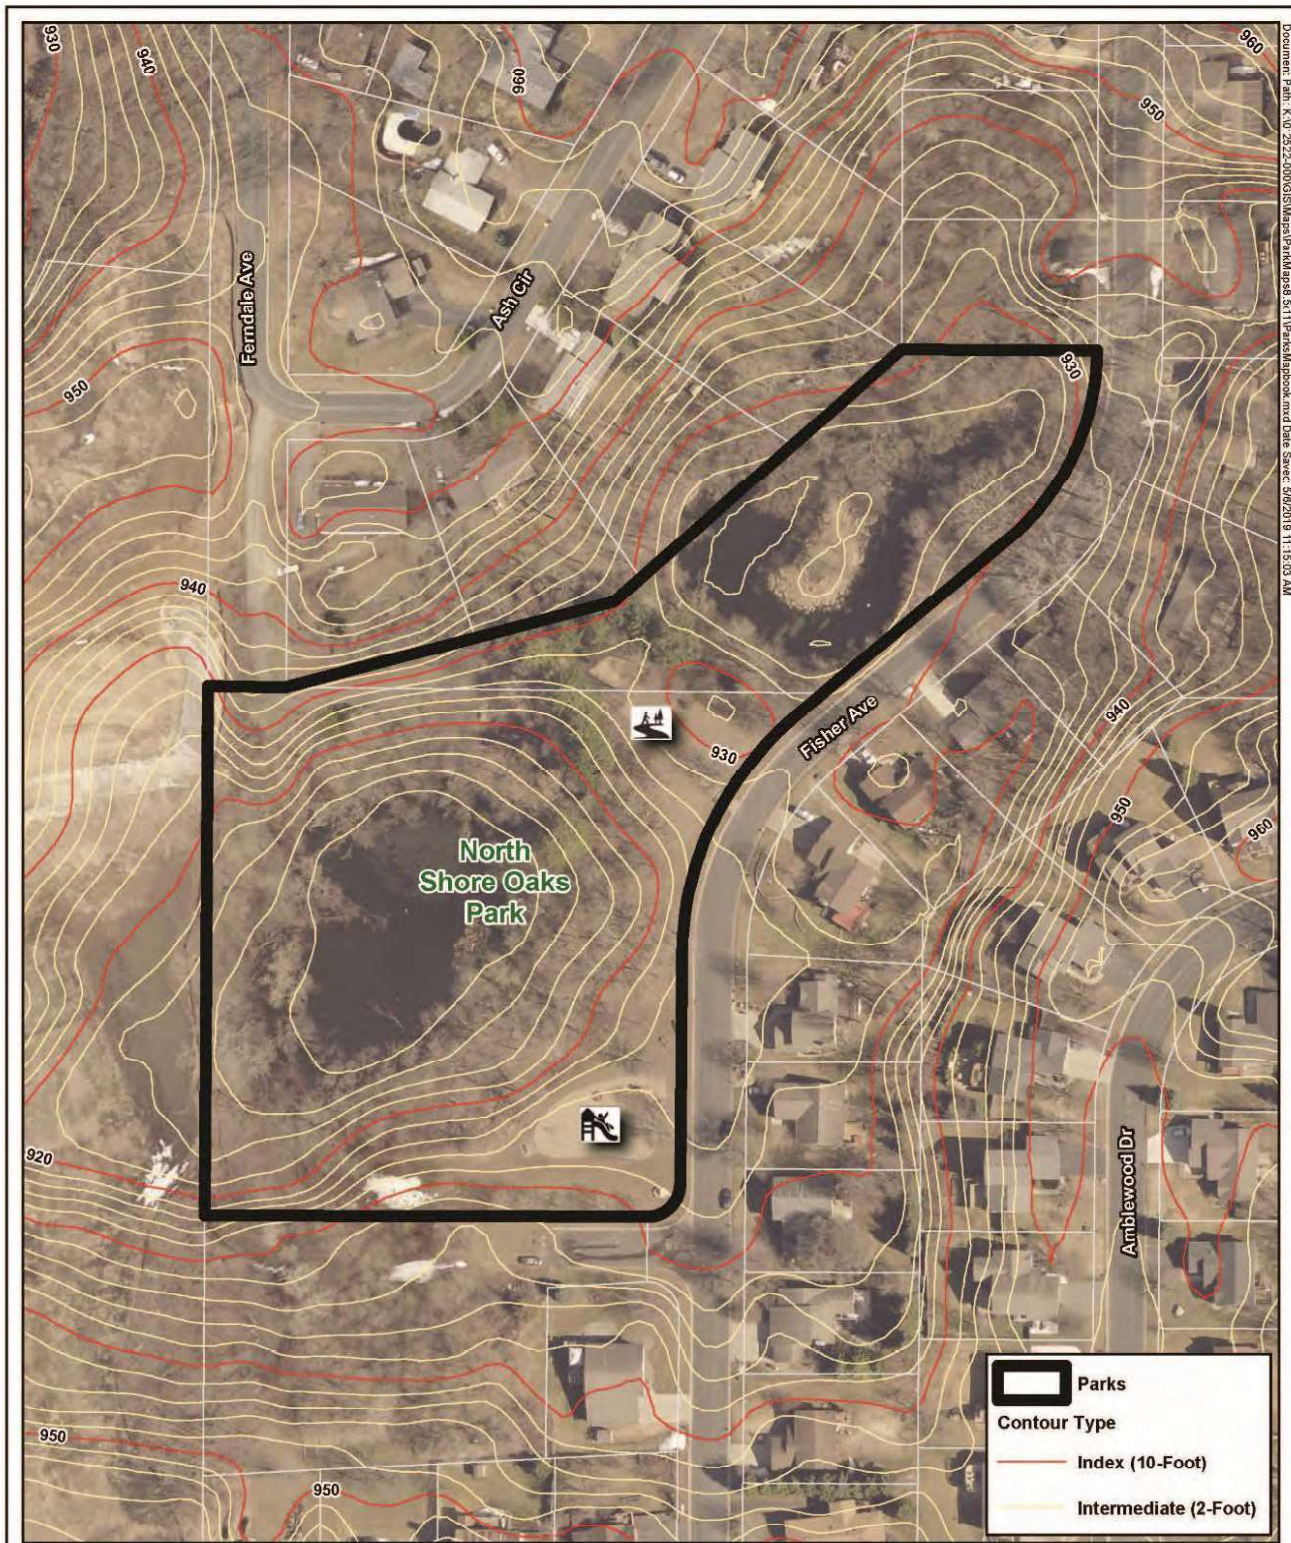
**North Shore Oaks Park**  
 Park System Master Plan  
 Prior Lake, MN

Description: This site is primarily wetlands with a maintenance trail and a small, outdated playground by the street. The park is located within 1/3 of a mile from Trillium Cove Park as measured along the trail, and within a half mile from Sand Point Beach.

Parks
<b>Contour Type</b>	
 	Index (10-Foot)
 	Intermediate (2-Foot)

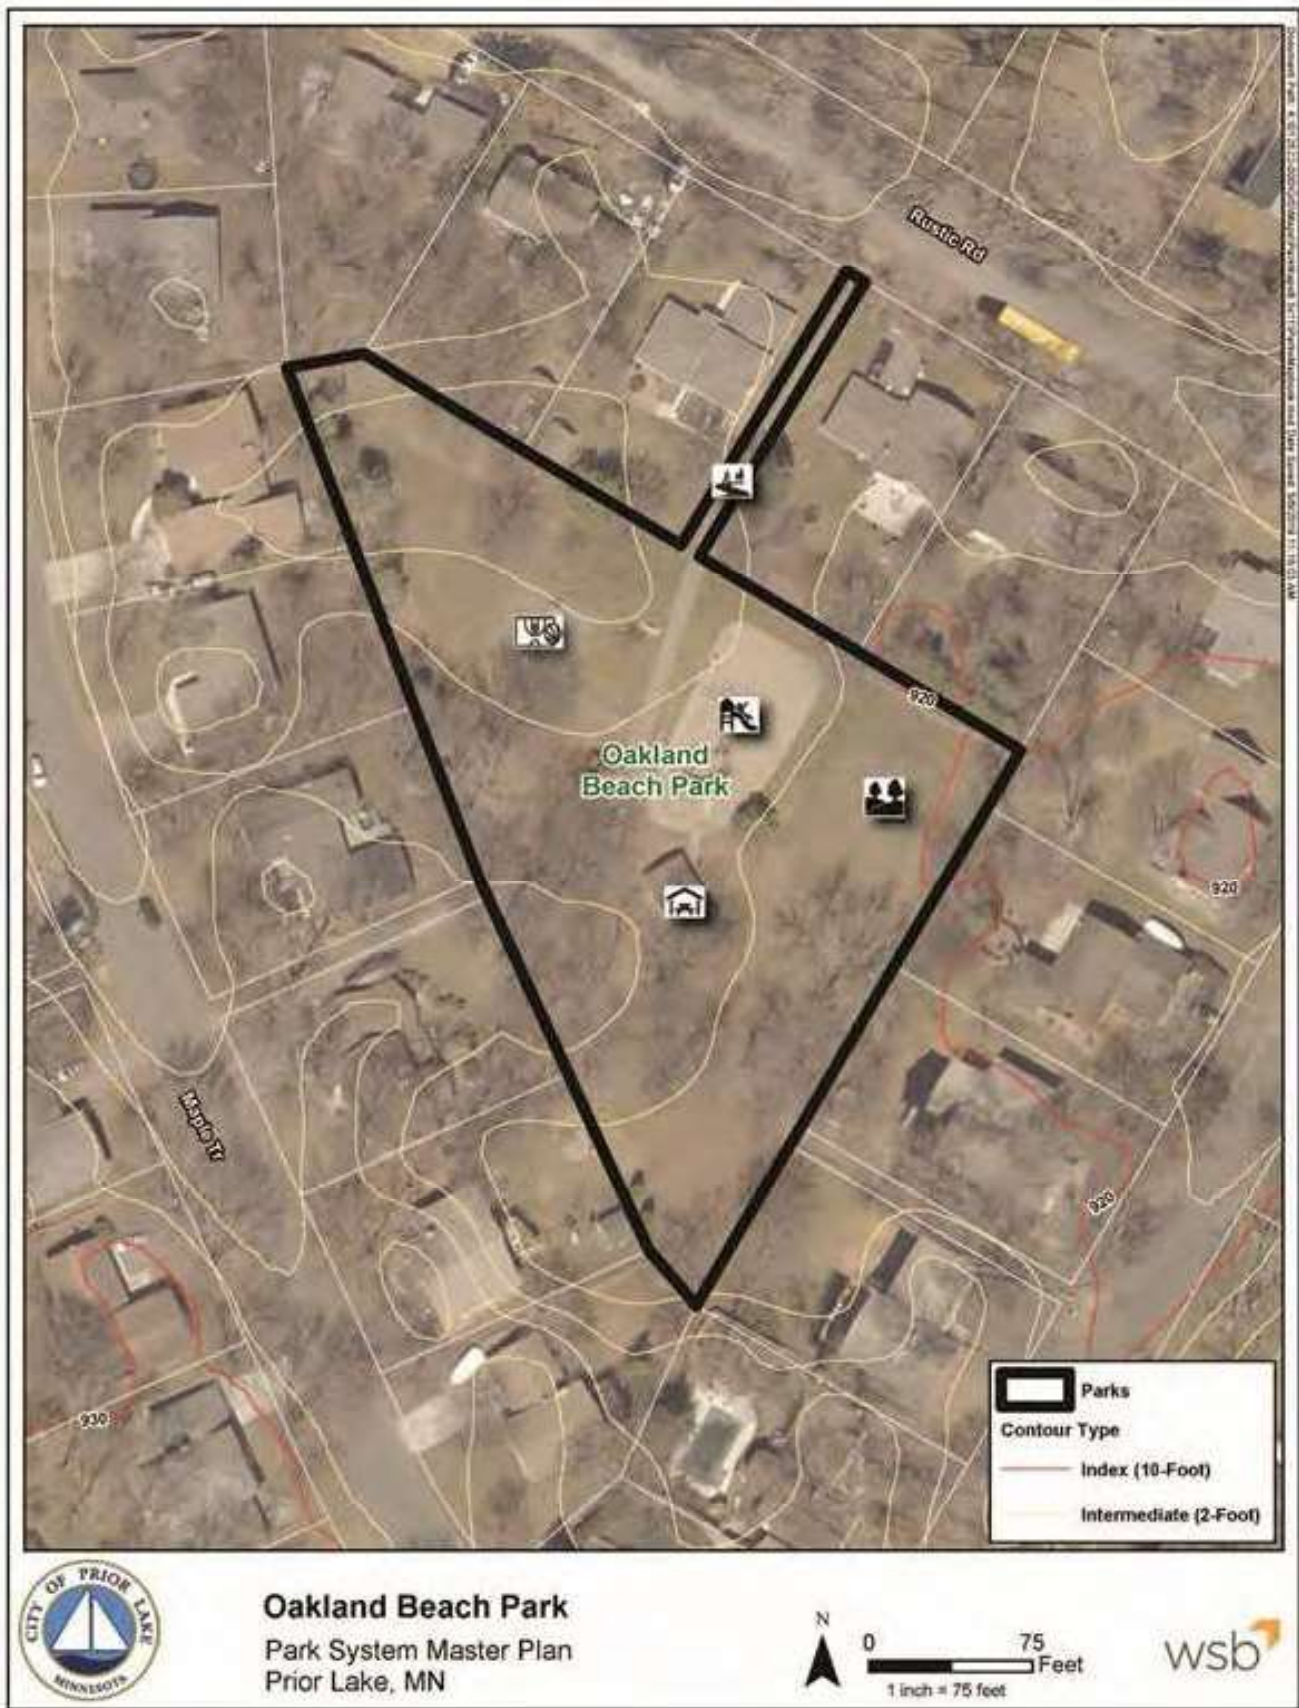
**Oakland Beach Park**  
Park System Master Plan  
Prior Lake, MN

**Description:** This small neighborhood park services an isolated neighborhood and is completely surrounded by homes so is very hidden. The “Beach” in the name is deceiving, though the neighborhood is along the Prior Lake.

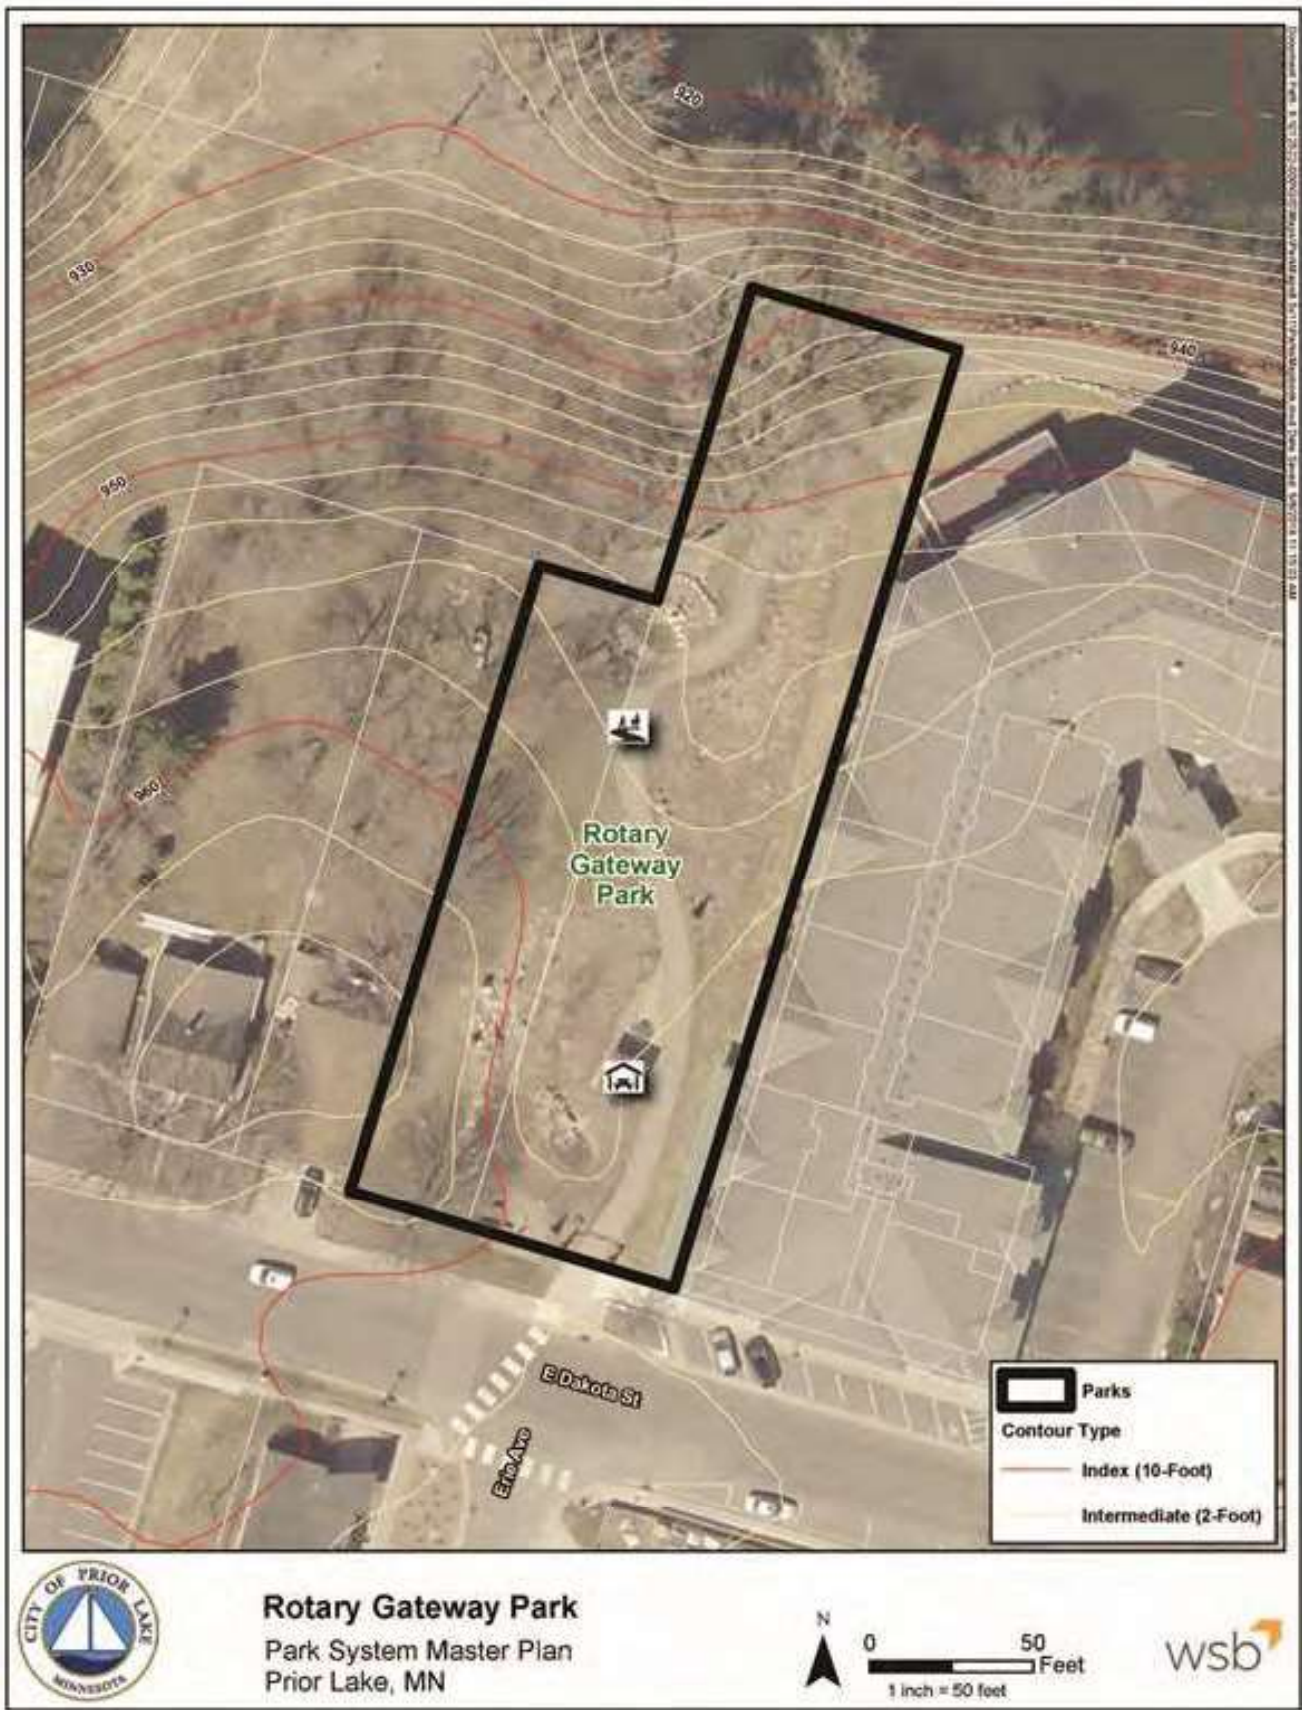
**Rotary Gateway Park**  
Park System Master Plan  
Prior Lake, MN

Description: Special use mini-park with specialty gardens that act as a gateway connection between downtown Prior Lake and Lakefront Park.

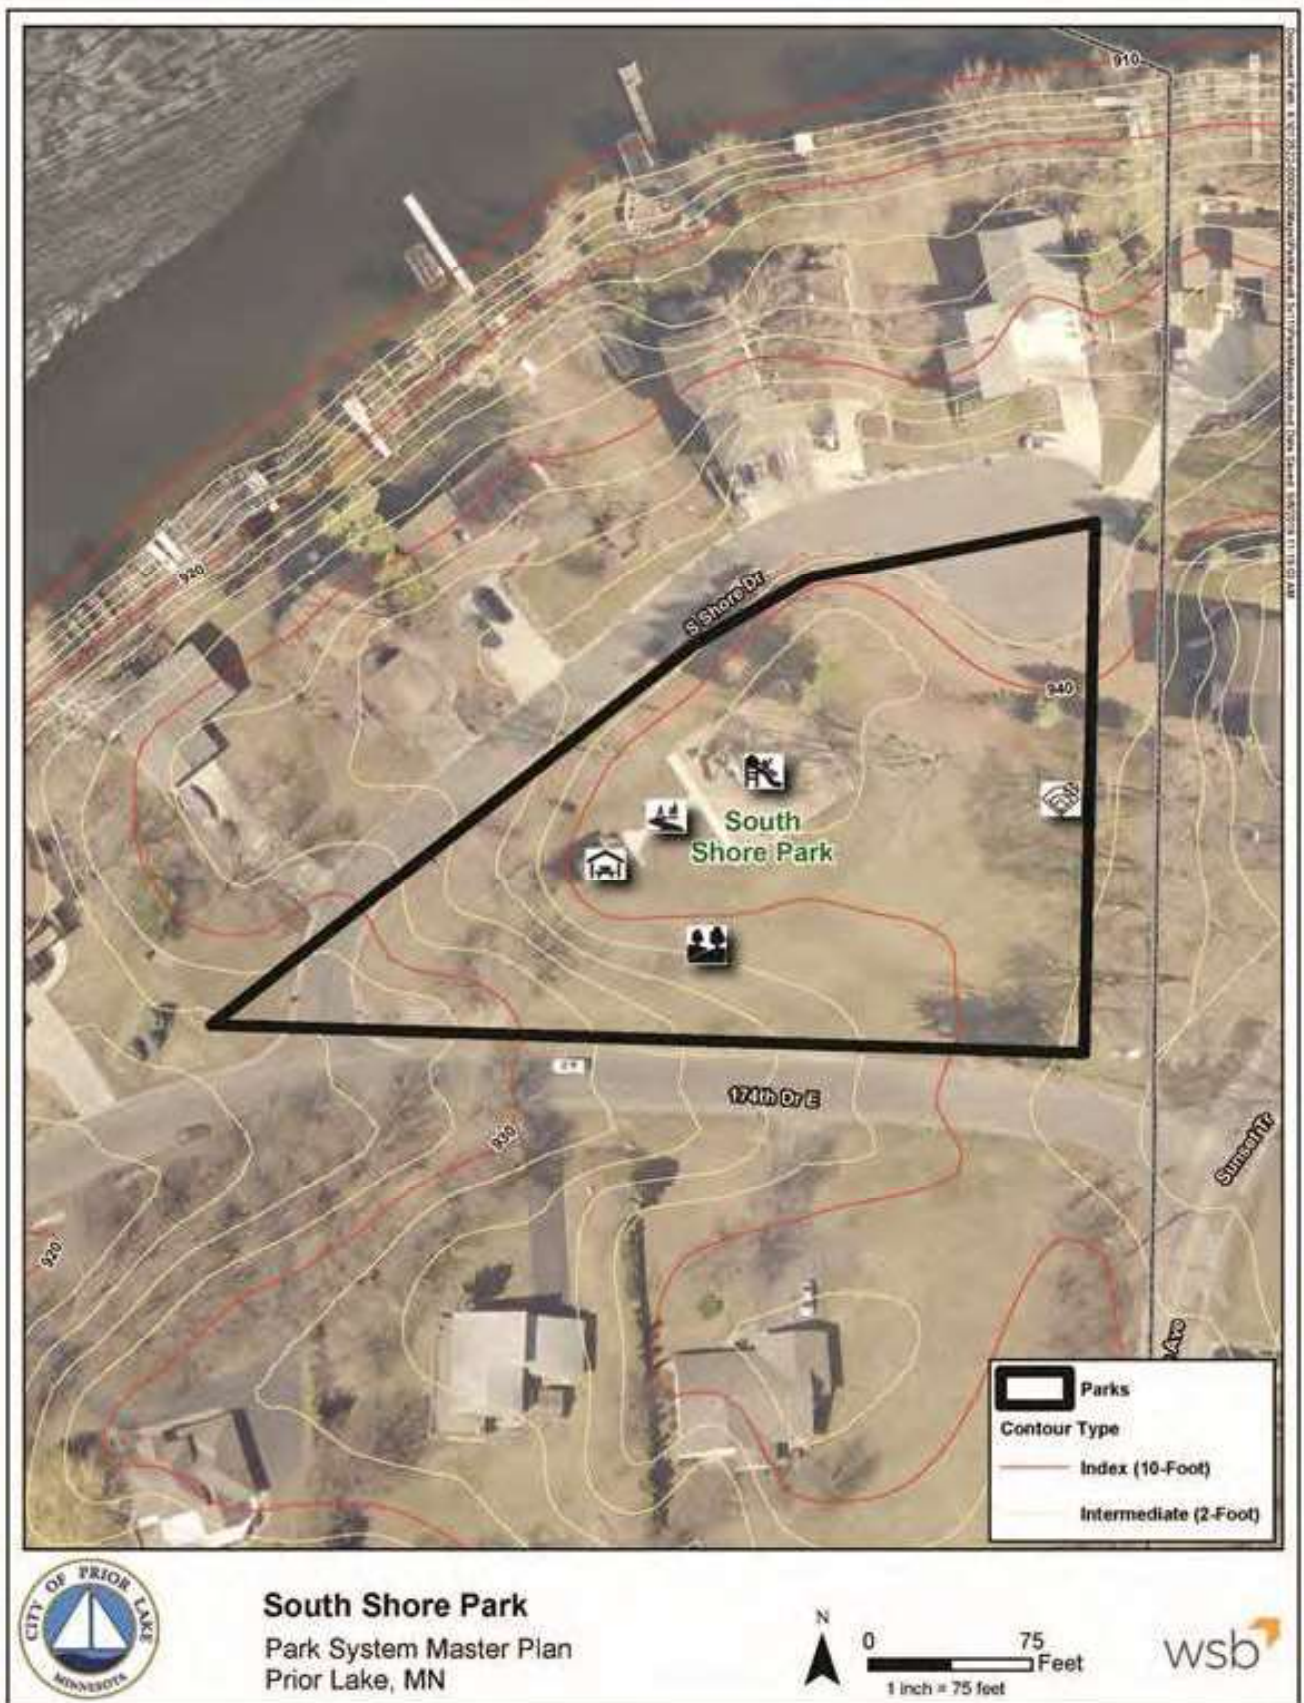
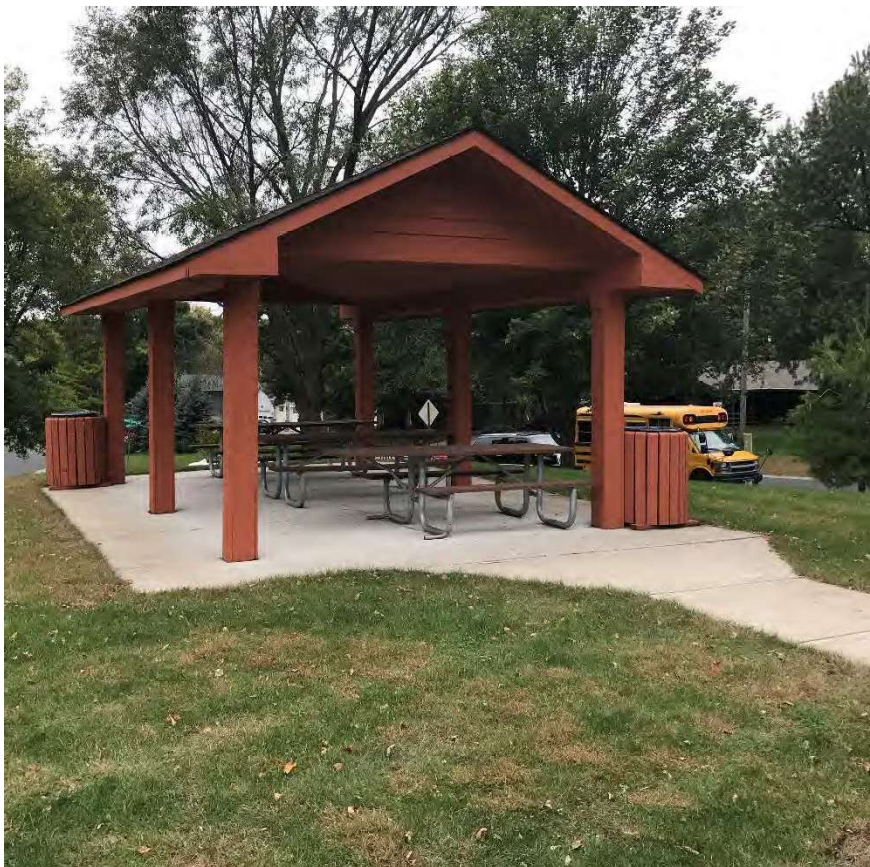
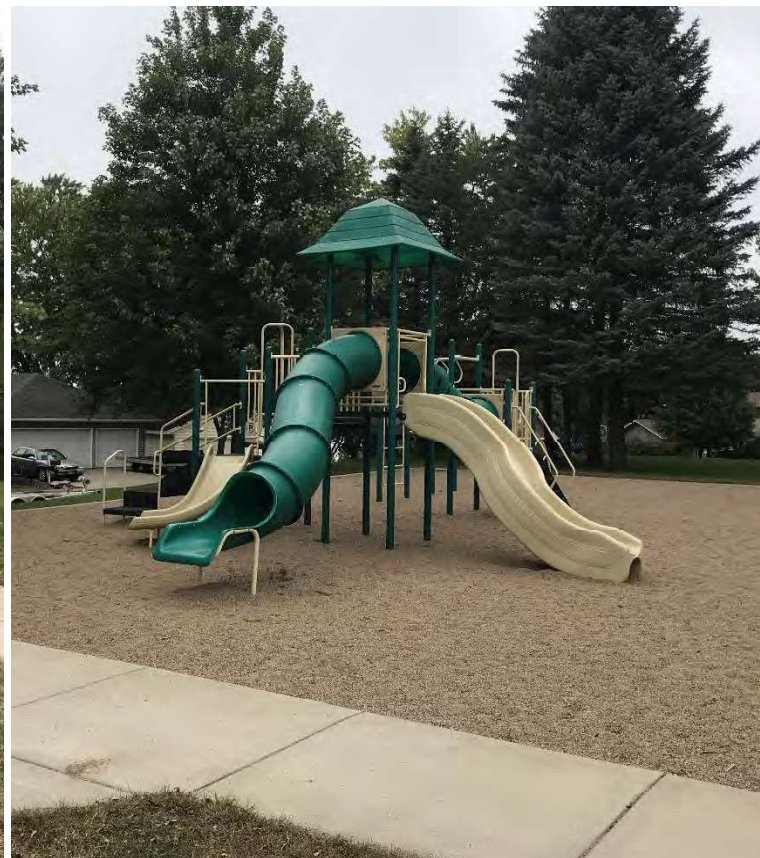
**South Shore Park**  
 Park System Master Plan  
 Prior Lake, MN

**Description:** Small neighborhood park that sits up on a hill and primarily only serves the adjacent homes in this area. A lack of any kind of parking allowed or a conflict with boat and trailer parking in the street makes this park feel very inaccessible and very private.

Overall Condition: Park is in fair to poor condition and amenities are older and will need to be replaced in the near future.
